# Manhole Inspection Summary

Manhole # S45I2\_039MH

**Location** Address: **Elmtree St. Dead End**

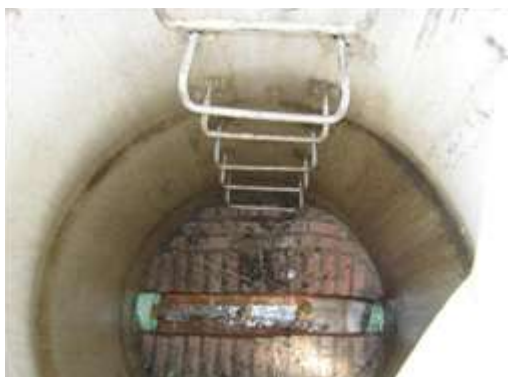
Defect 1

Infiltration: ☐ None ☐ Joint ☐ Cracks ☐ Mortar ☐ Roots ☒ **Wall**

wall infiltration

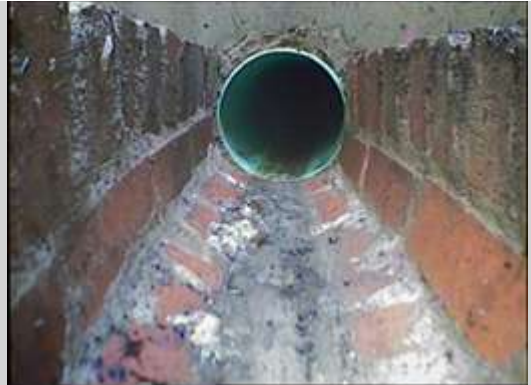
12 O'Clock Outflow

8 in. Circular Gravity Sewer  
Pipe Out @ 12 O'Clock

Pipe Height: **9.6** (in.) Rod and Bar (Angled)  
Pipe Material: **PVC** ☐ Pipe Lined  
Invert Depth: **8.78** (ft.) Flow Characteristics: **Fast**  
Deposits: ☒ None ☐ Mud ☐ Sludge ☐ Debris ☐ Grease  
Silt Depth: (in.) Deposits Extent:  
Infiltration: **None** Pipe Seal Cond: **Sound**

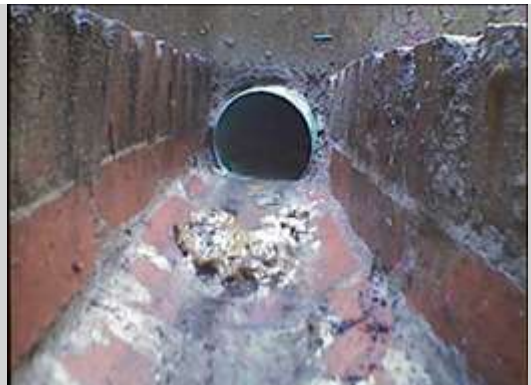
6 O'Clock Inflow

8 in. Circular Gravity Sewer  
Pipe In @ 6 O'Clock

Pipe Height: **8.4** (in.) Rod and Bar (Angled)  
Pipe Material: **PVC** ☐ Pipe Lined  
Invert Depth: **8.80** (ft.) Flow Characteristics: **Fast**  
Deposits: ☒ None ☐ Mud ☐ Sludge ☐ Debris ☐ Grease  
Silt Depth: (in.) Deposits Extent:  
Infiltration: **None** Pipe Seal Cond: **Sound**
